Manhole Inspection Summary

Manhole # S35A__019MH

Insp Date: **11/14/07 8:38 AM**

Location Address: **649 st.paul st**

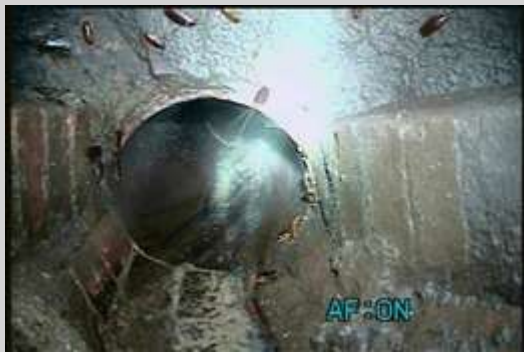
12 O'Clock Outflow

8 in. Circular Gravity Sewer
Pipe Out @ 12 O'Clock

Invert Depth: **12.90** (ft.) Flow Characteristics: **Slow**

Infiltration: **None** Pipe Seal Cond: **Unknown**

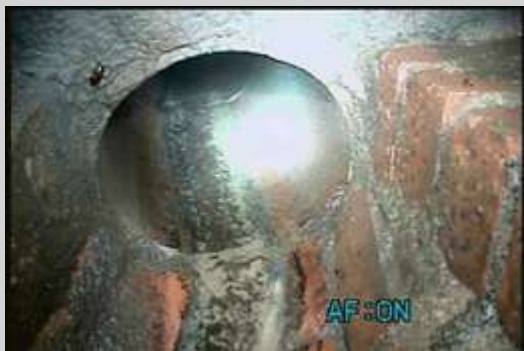
3 O'Clock Inflow

8 in. Circular Gravity Sewer
Pipe In @ 3 O'Clock

Infiltration: **None** Pipe Seal Cond: **Unknown**
